AVIATION INVESTIGATION REPORT

A04P0153

AIR PROXIMITY – SAFETY NOT ASSURED

VANCOUVER TOWER/AREA CONTROL CENTRE

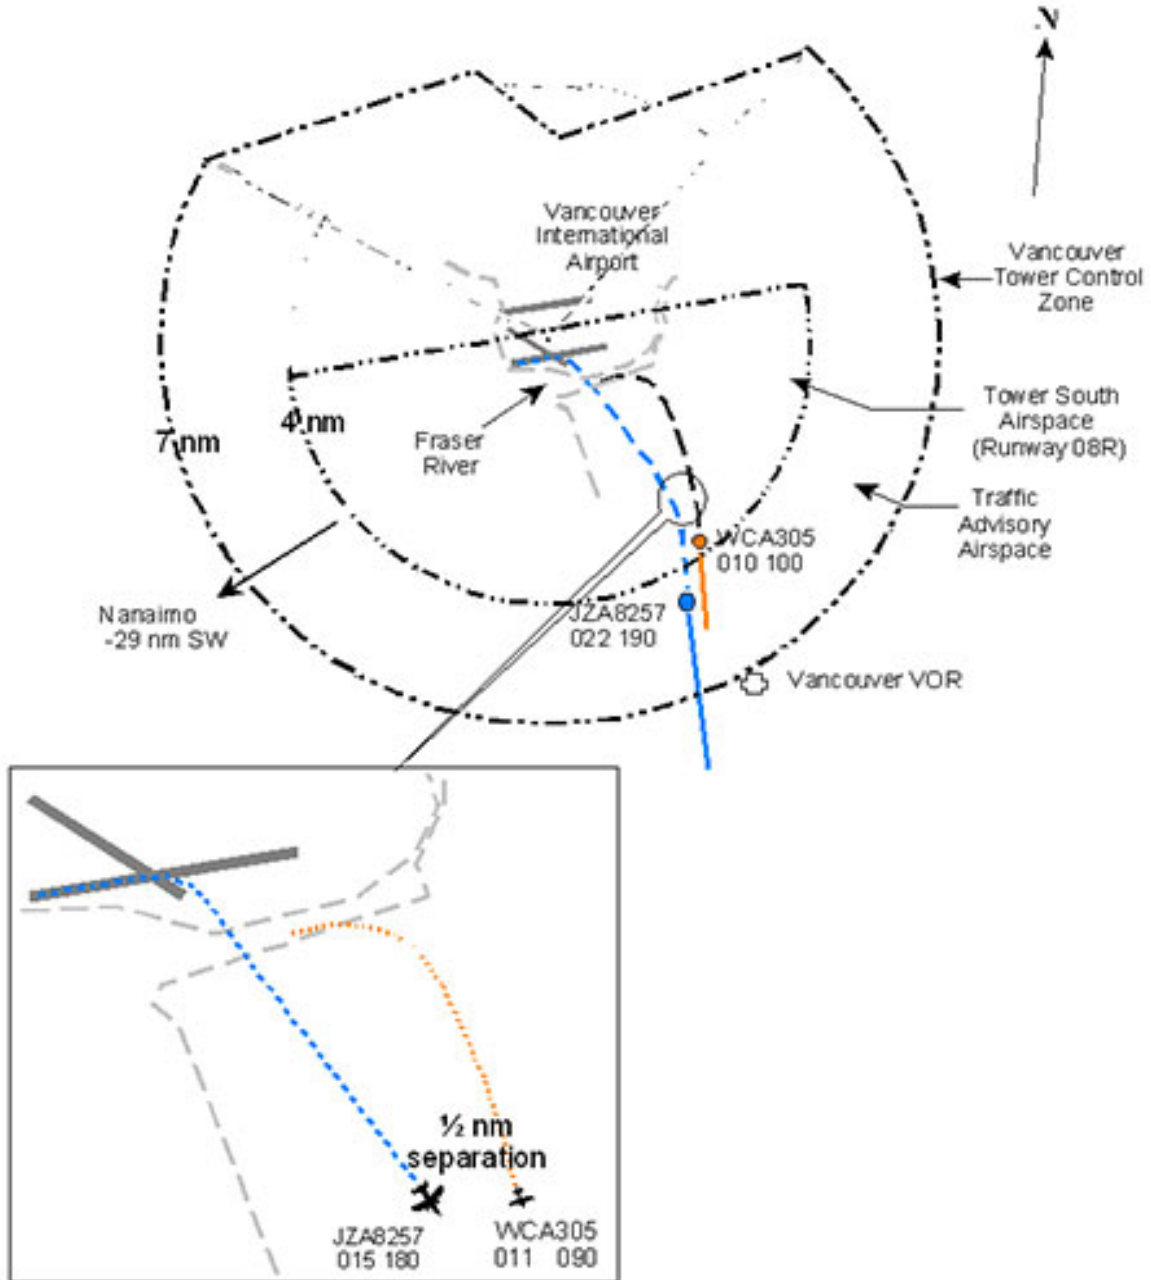
Appendix A – Area Diagram

At 0818:47, the two aircraft reached their closest proximity laterally, approximately ½ nm. At this point, they were separated only 400 feet vertically and safety was not assured.

JZA8257 sights WCA305 and turns right to avoid
